DEPARTMENT OF NATURAL RESOURCES  
DIVISION OF OIL, GAS AND MINING

October 22, 1997

RE: Site Inspection, Interstate Brick, Koosharem Mine, M/031/002, Piute County, Utah

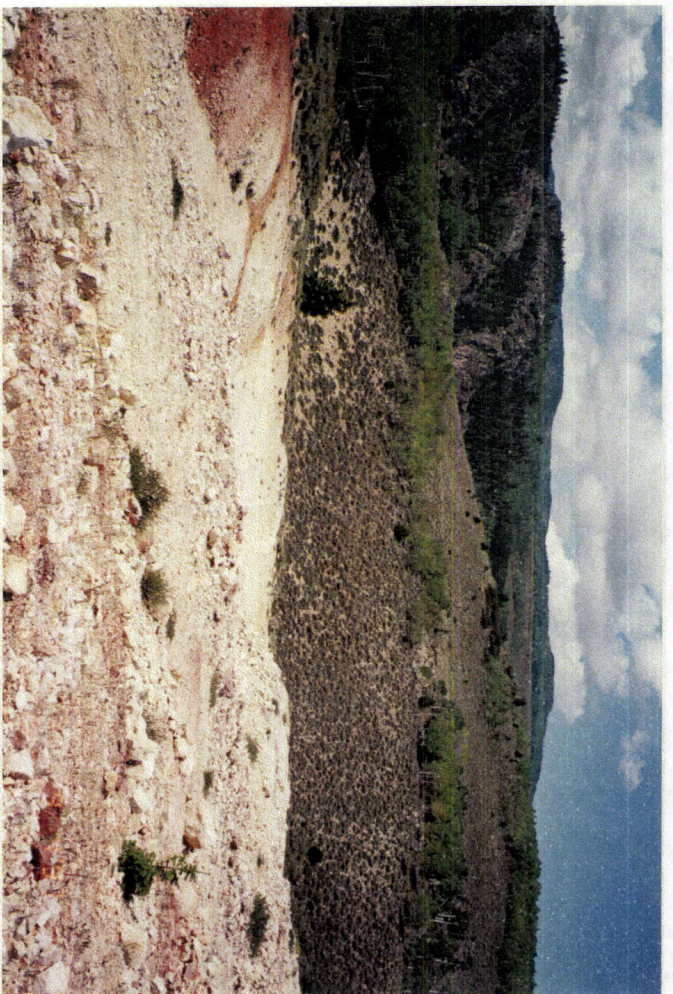
DISURBANCE ON USES

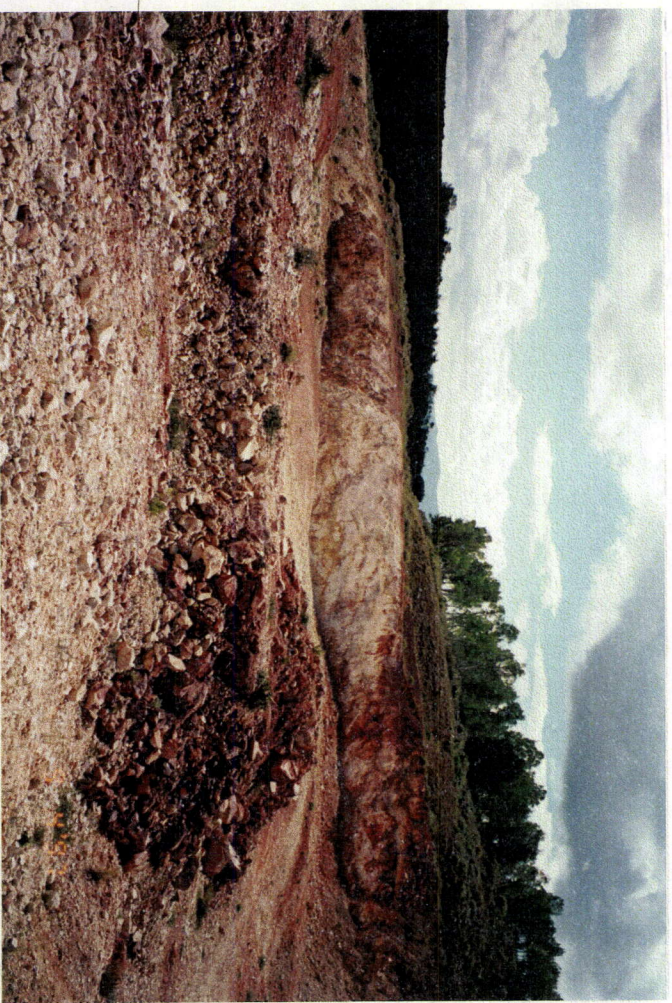
LOOKING N S  
 HIGHWAY ON USFS  
 M/031/002

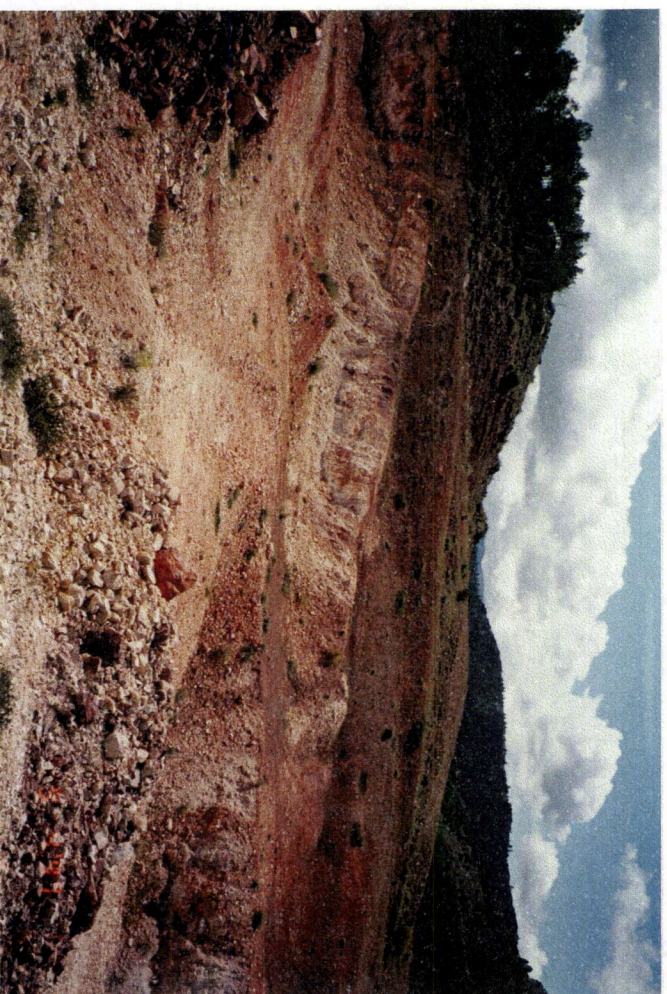
LOOKING N S  
 HIGHWAY ON USFS  
 M/031/002

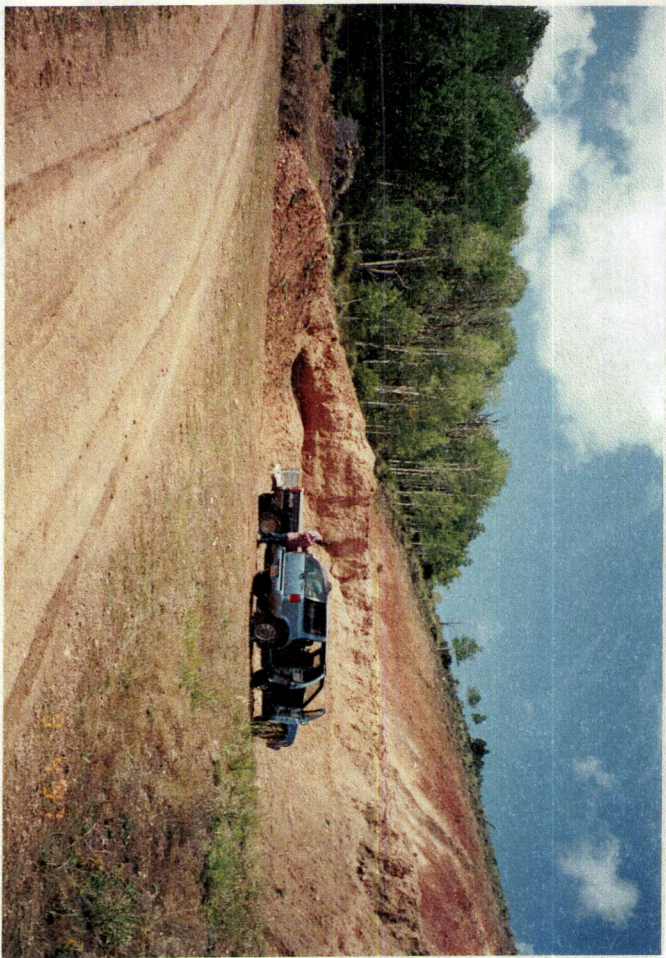
- EXISTING DISTURBANCE ON ROAD  
BEYOND KOOSHAREM PIT

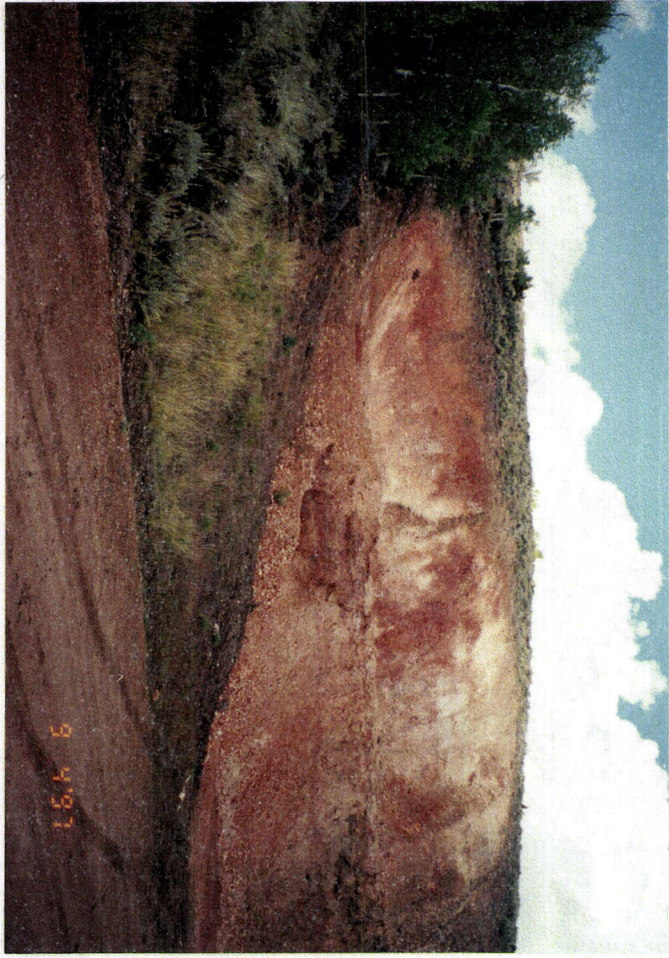
- EXISTING DISTURBANCE ON ROAD  
BEYOND KOOSHAREM PIT

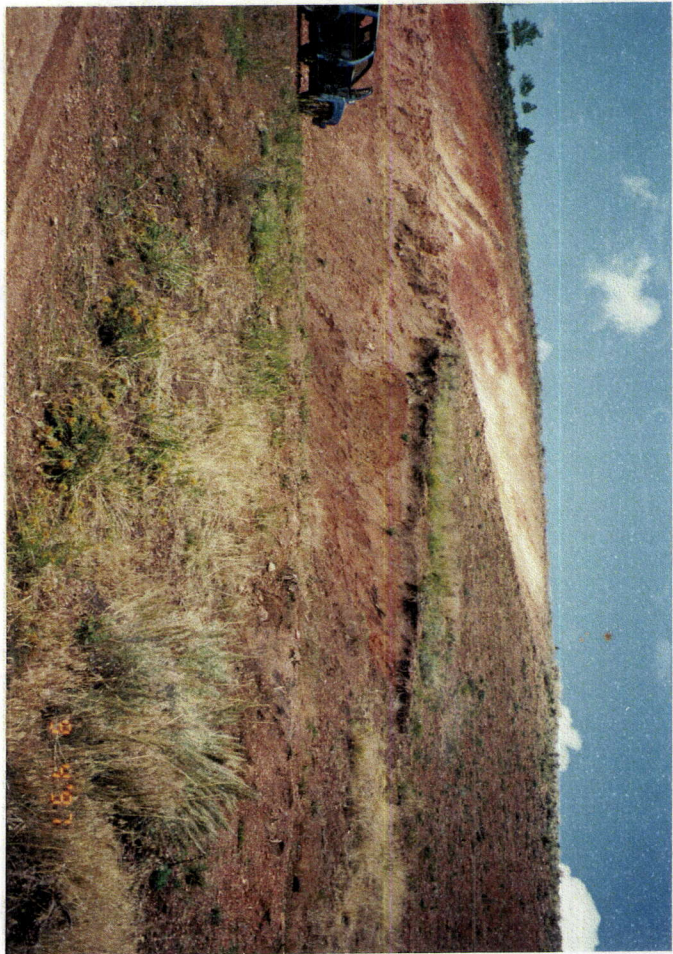
- EXISTING DISTURBANCE ON ROAD  
BEYOND KOOSHAREM PIT

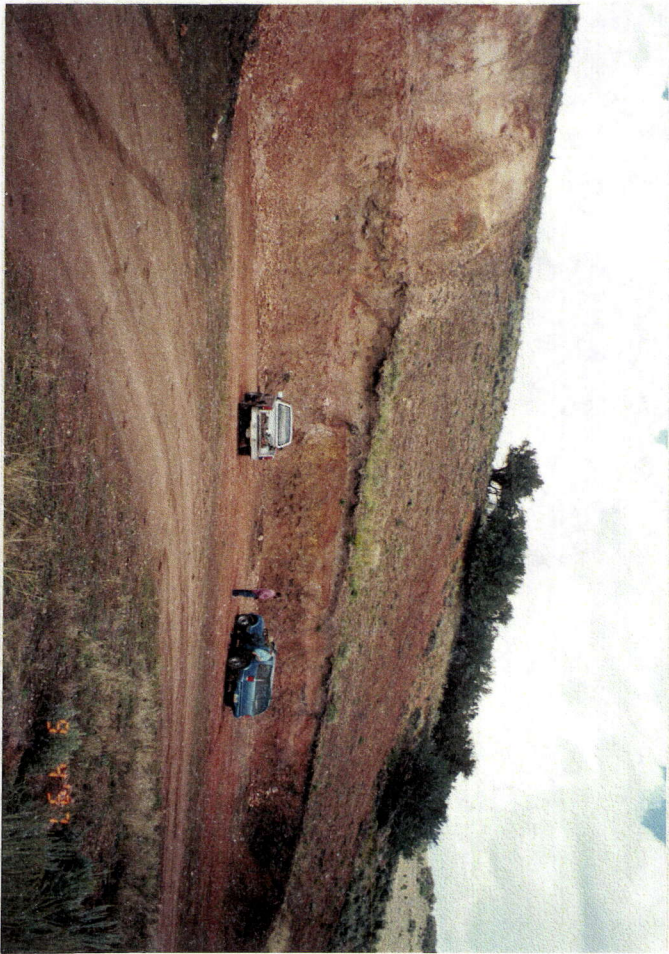
- EXISTING DISTURBANCE ON ROAD BEYOND  
KOOSHAREM PIT
